NONDESTRUCTIVE EVALUATIONS OF COM-
POSITE HEATSHIELD MATERIALS BEFORE
AND AFTER AN UNDERGROUND NUCLEAR
EXPOSURE

Southern Research Institute

Air Force Weapons Laboratory

AFWL-TR-73-247

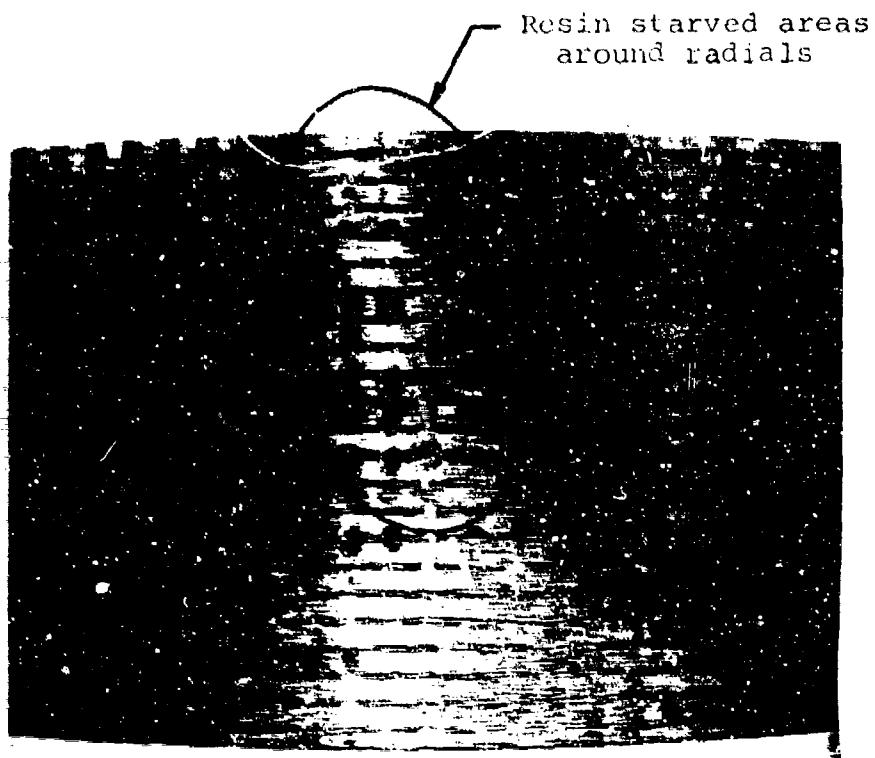
Radial View - Outer Surface
(1.5X)

Figure 17. Photograph Showing Visual Resin-Starved Areas Around Radials in Ring 2 from AVCO 3DCP

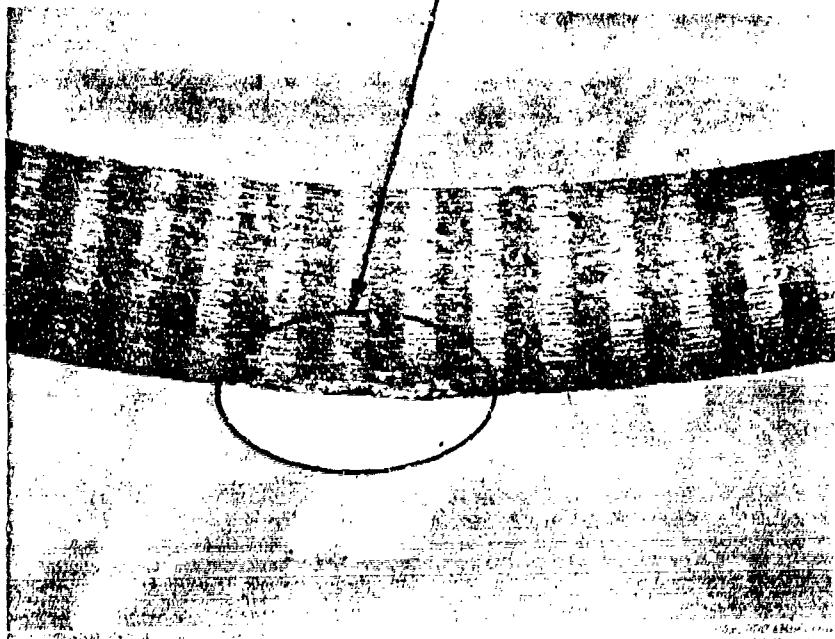
Axial View - Top Edge
(2.9X)

Bumped edge resulting in local
loosening of reinforcement -
size .0.4 inch long

Figure 18. Photograph Showing Bumped Outer Edge
on Ping 2 from AVCO 3DCP

| Ring No. | Bulk Density (gm/cm ³) | | SoRI Orientation (Deg.) | Axial Velocity (in./usec) | | Radial Velocity (in./usec) | | Radial Ultra Transmission (add db) | | After Thickness Profile (inch) | Visual/X-ray, Liquid Penetrant Results |
|---|---|---|---|---|---|---|---|--|---|---|---|
| | | | 270 | 0.3609 | | 0.1625 | | 28.5 | | | 4. Top outer edge had been bumped resulting local matrix/reinforcement interface failure, Figure 18. Bumped area measured 0.4 inch. |

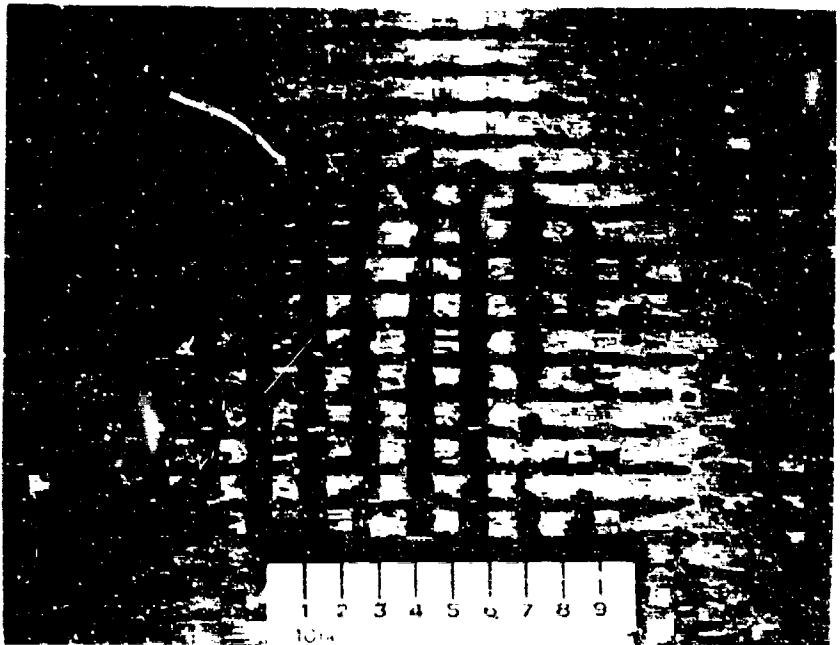
c. Radial View - Outer Surface
(2X)

Note: Missing pieces of axials and circumferentials typical on outer and inner surfaces

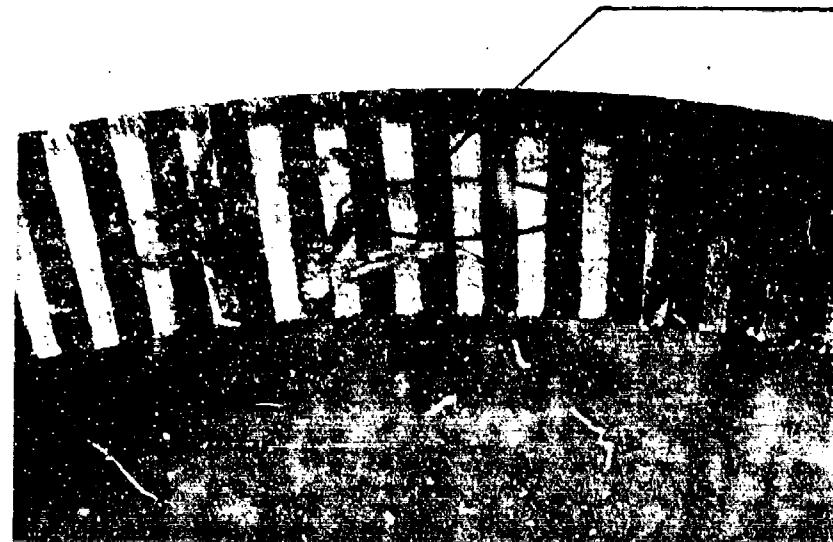
c. Axial View - Bottom Edge
(2.5X)

Single 0.34 in.
long circumferential
crack located in
bottom edge 0.25 in.
from inner edge and at
at 60-65°

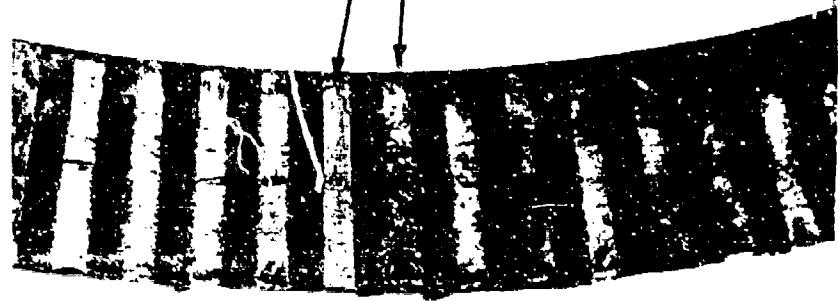
a. Axial View - Bottom Edge
(2.5X)

Missing and raised radials
located at 0-30°

Figure 36. Photographs Showing Structural
Change After Exposure in Ring
1109 - 35-3 from AVCO 3DCC
